**REPORT NUMBER: 301-MGA-2009-006**

**SAFETY COMPLIANCE TESTING FOR FMVSS 301R  
FUEL SYSTEM INTEGRITY – REAR IMPACT**

**VOLKSWAGEN AG GERMANY  
2009 VOLKSWAGEN GTI  
NHTSA NUMBER: C95801**

**PREPARED BY:  
MGA RESEARCH CORPORATION  
5000 WARREN ROAD  
BURLINGTON, WI 53105**

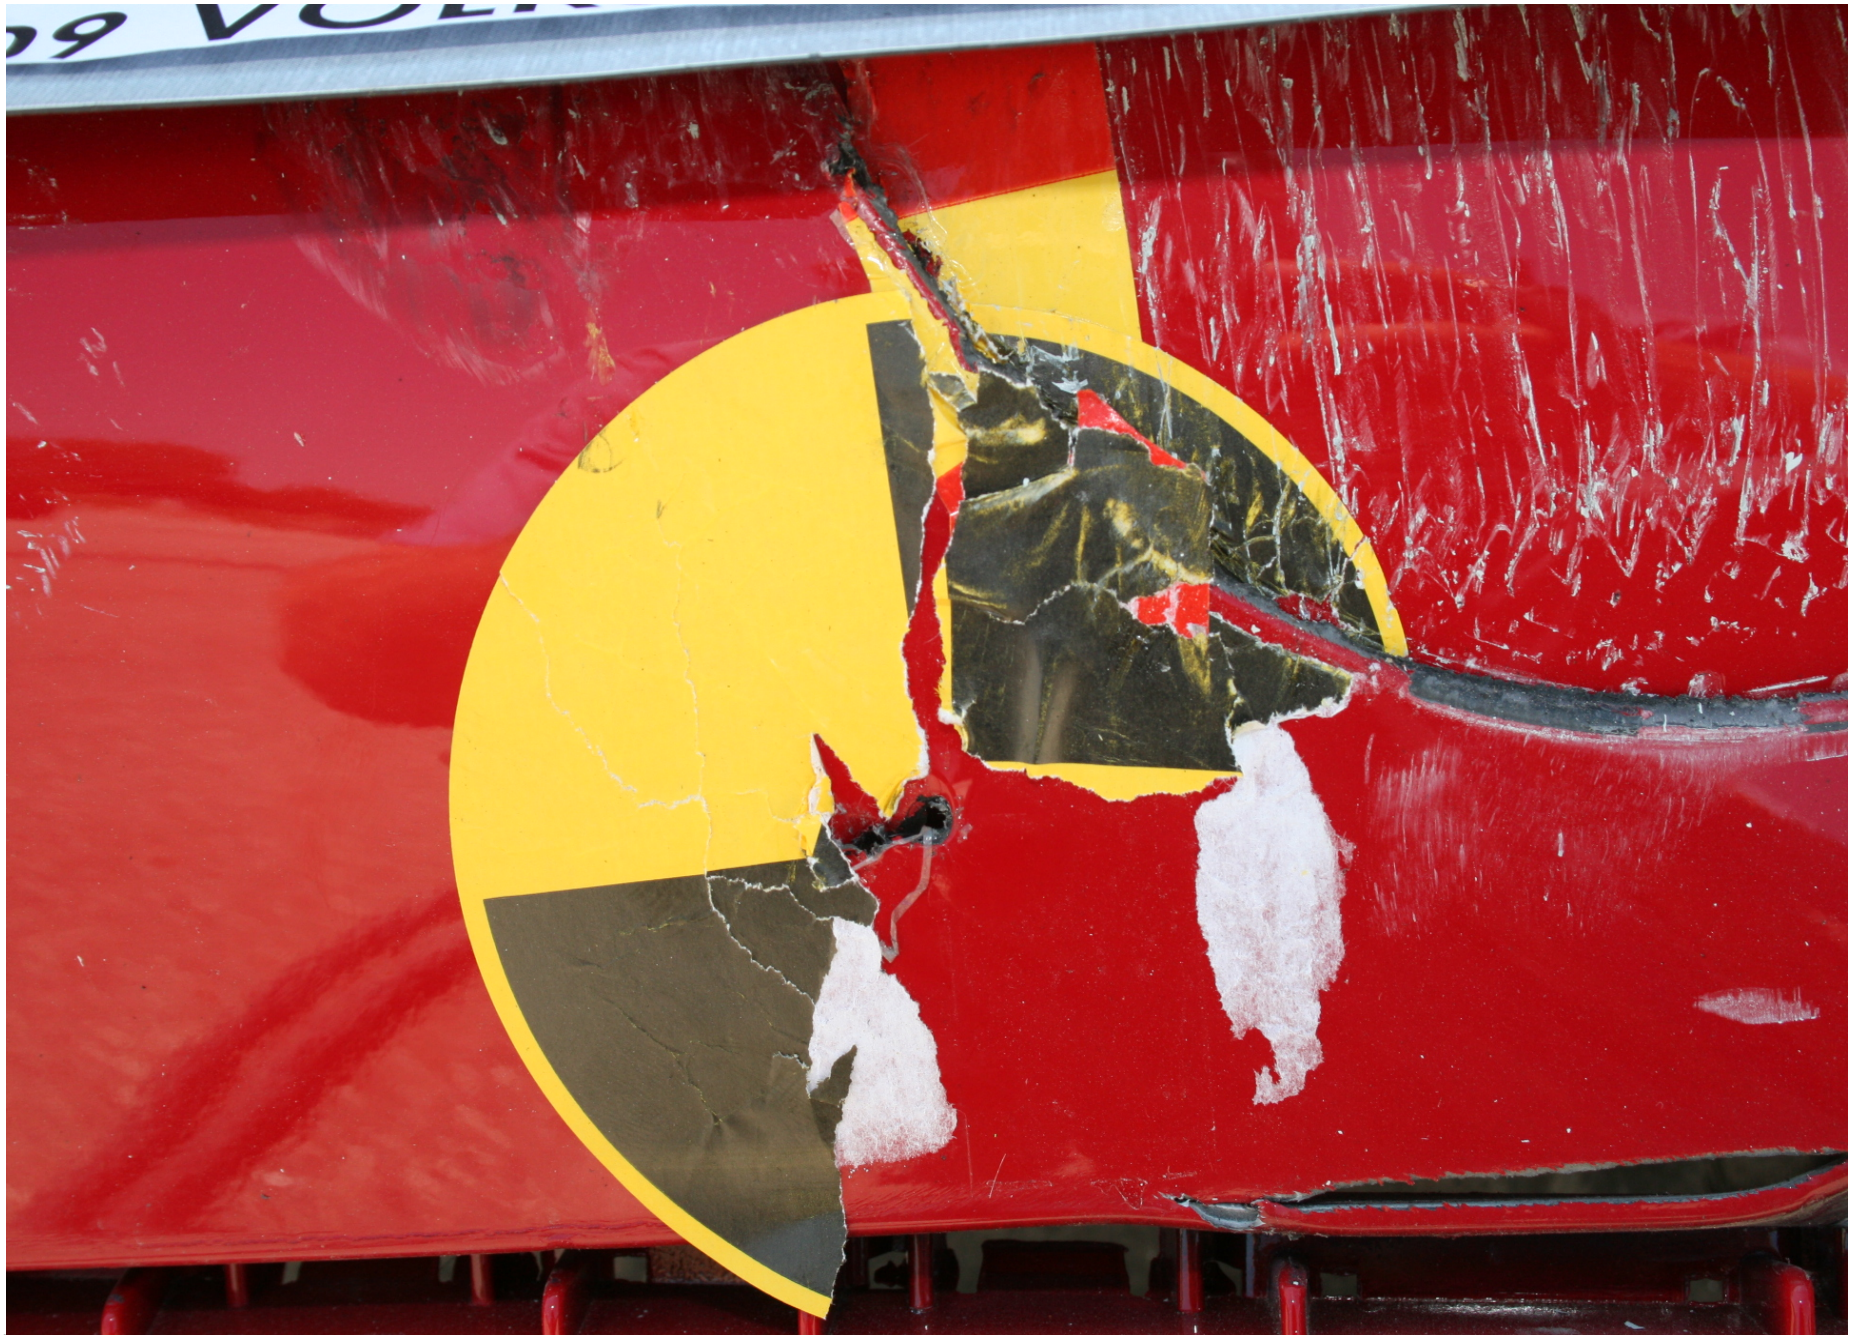
Post-Test Impact Point

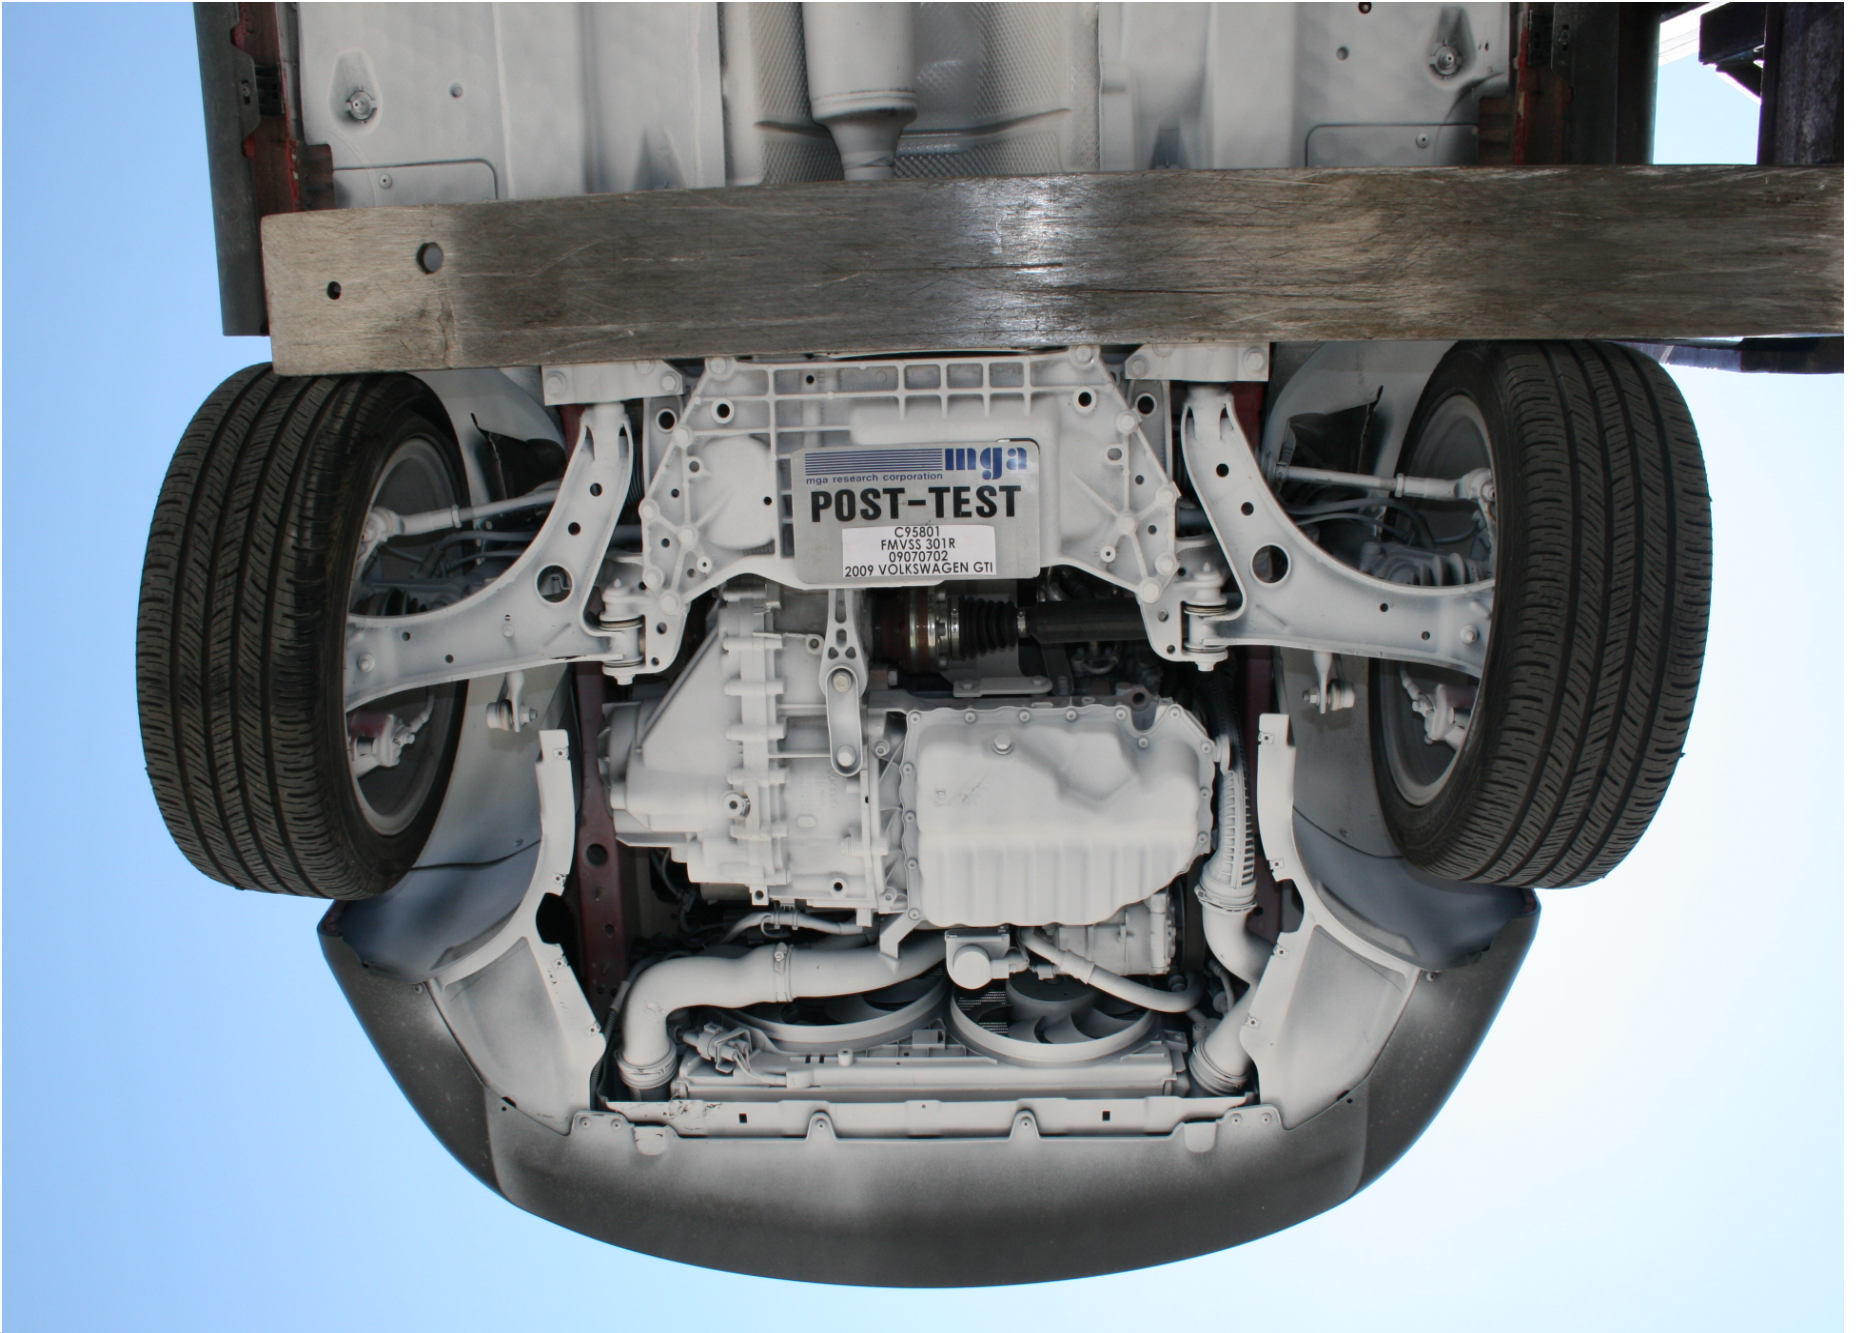
Post-Test Underbody View 1

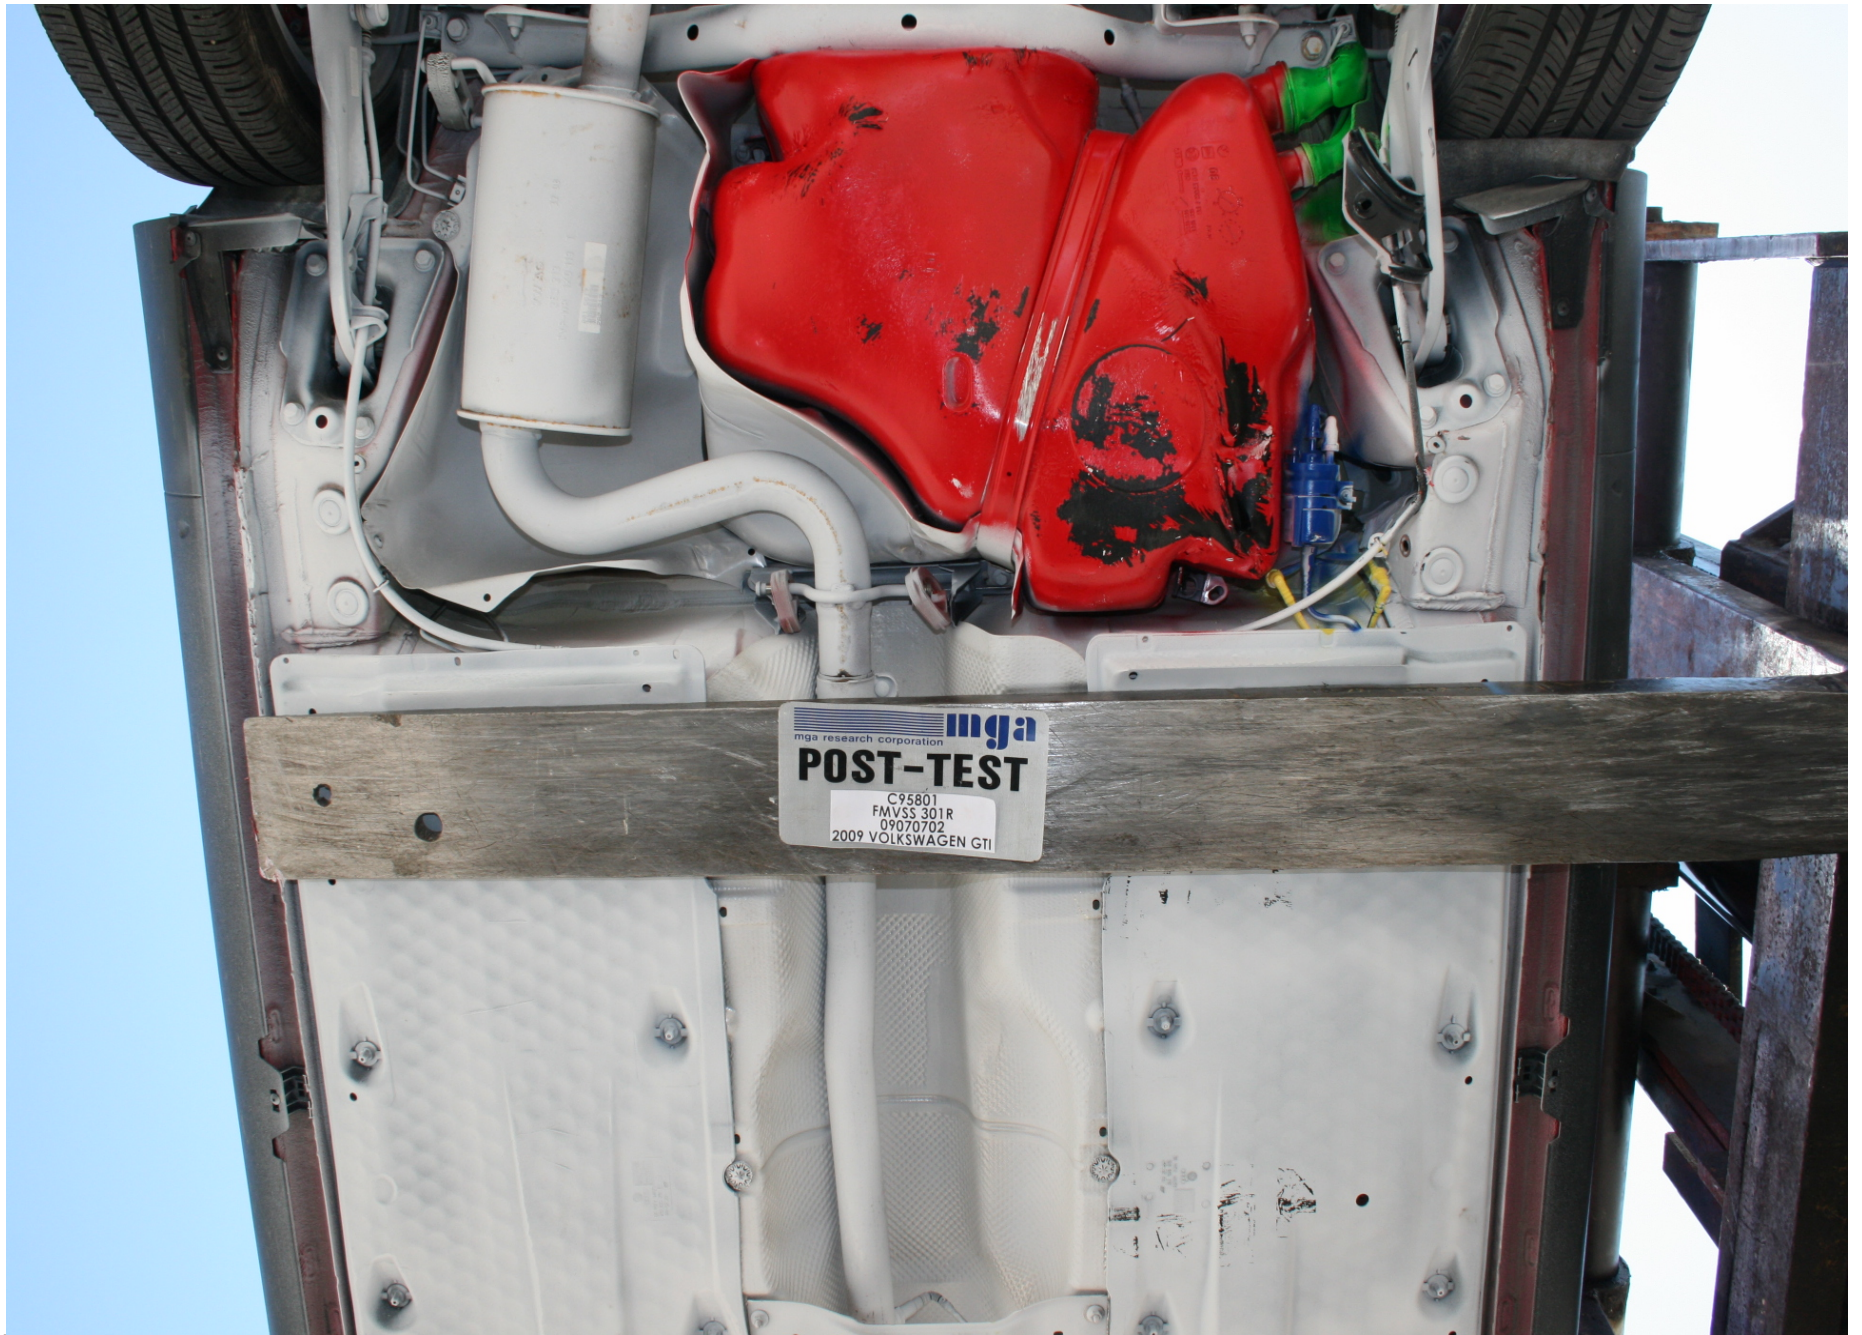
Post-Test Underbody View 2

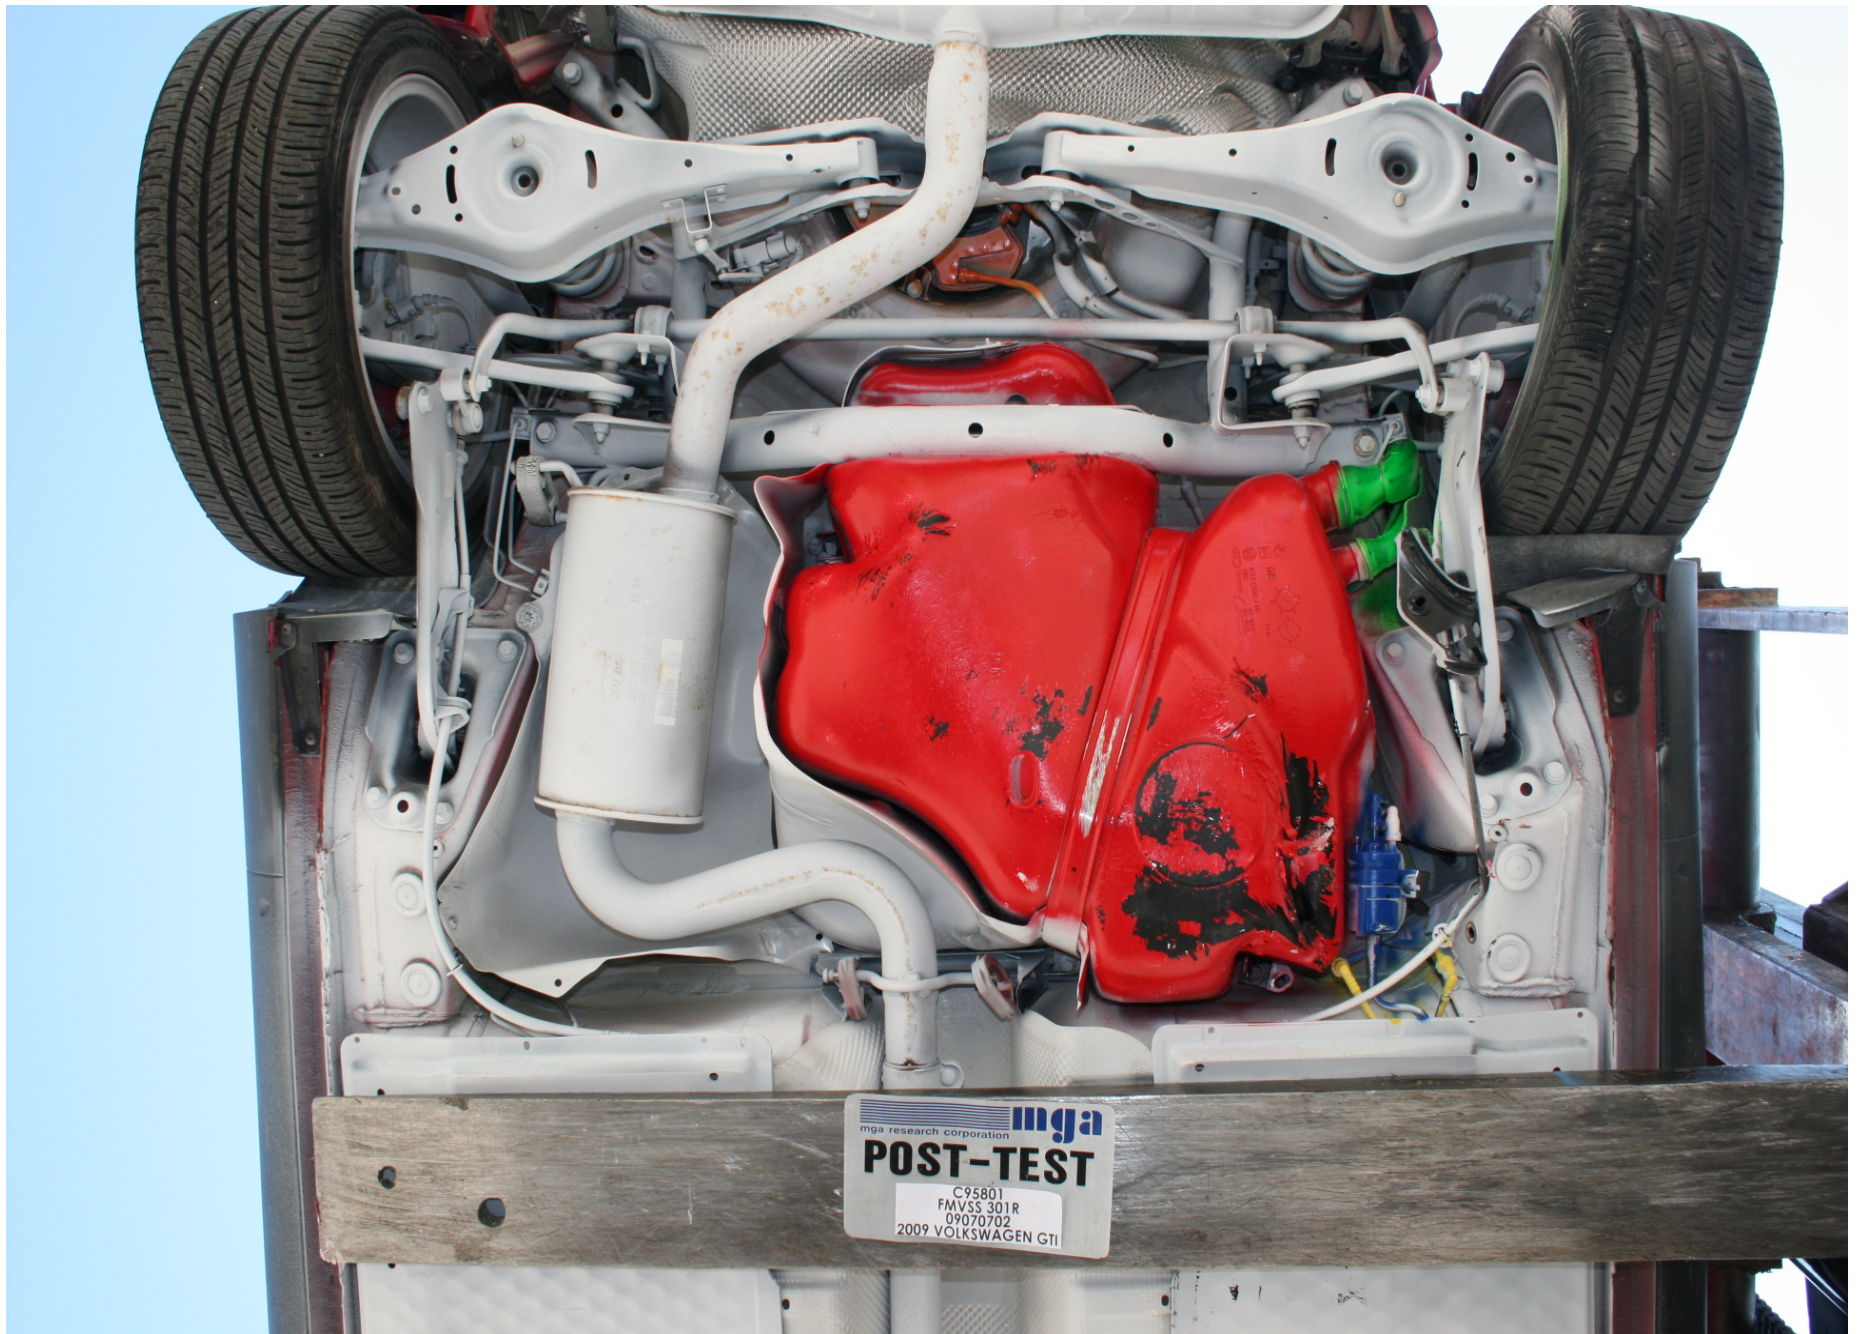
A-28.

Post-Test Underbody View 3

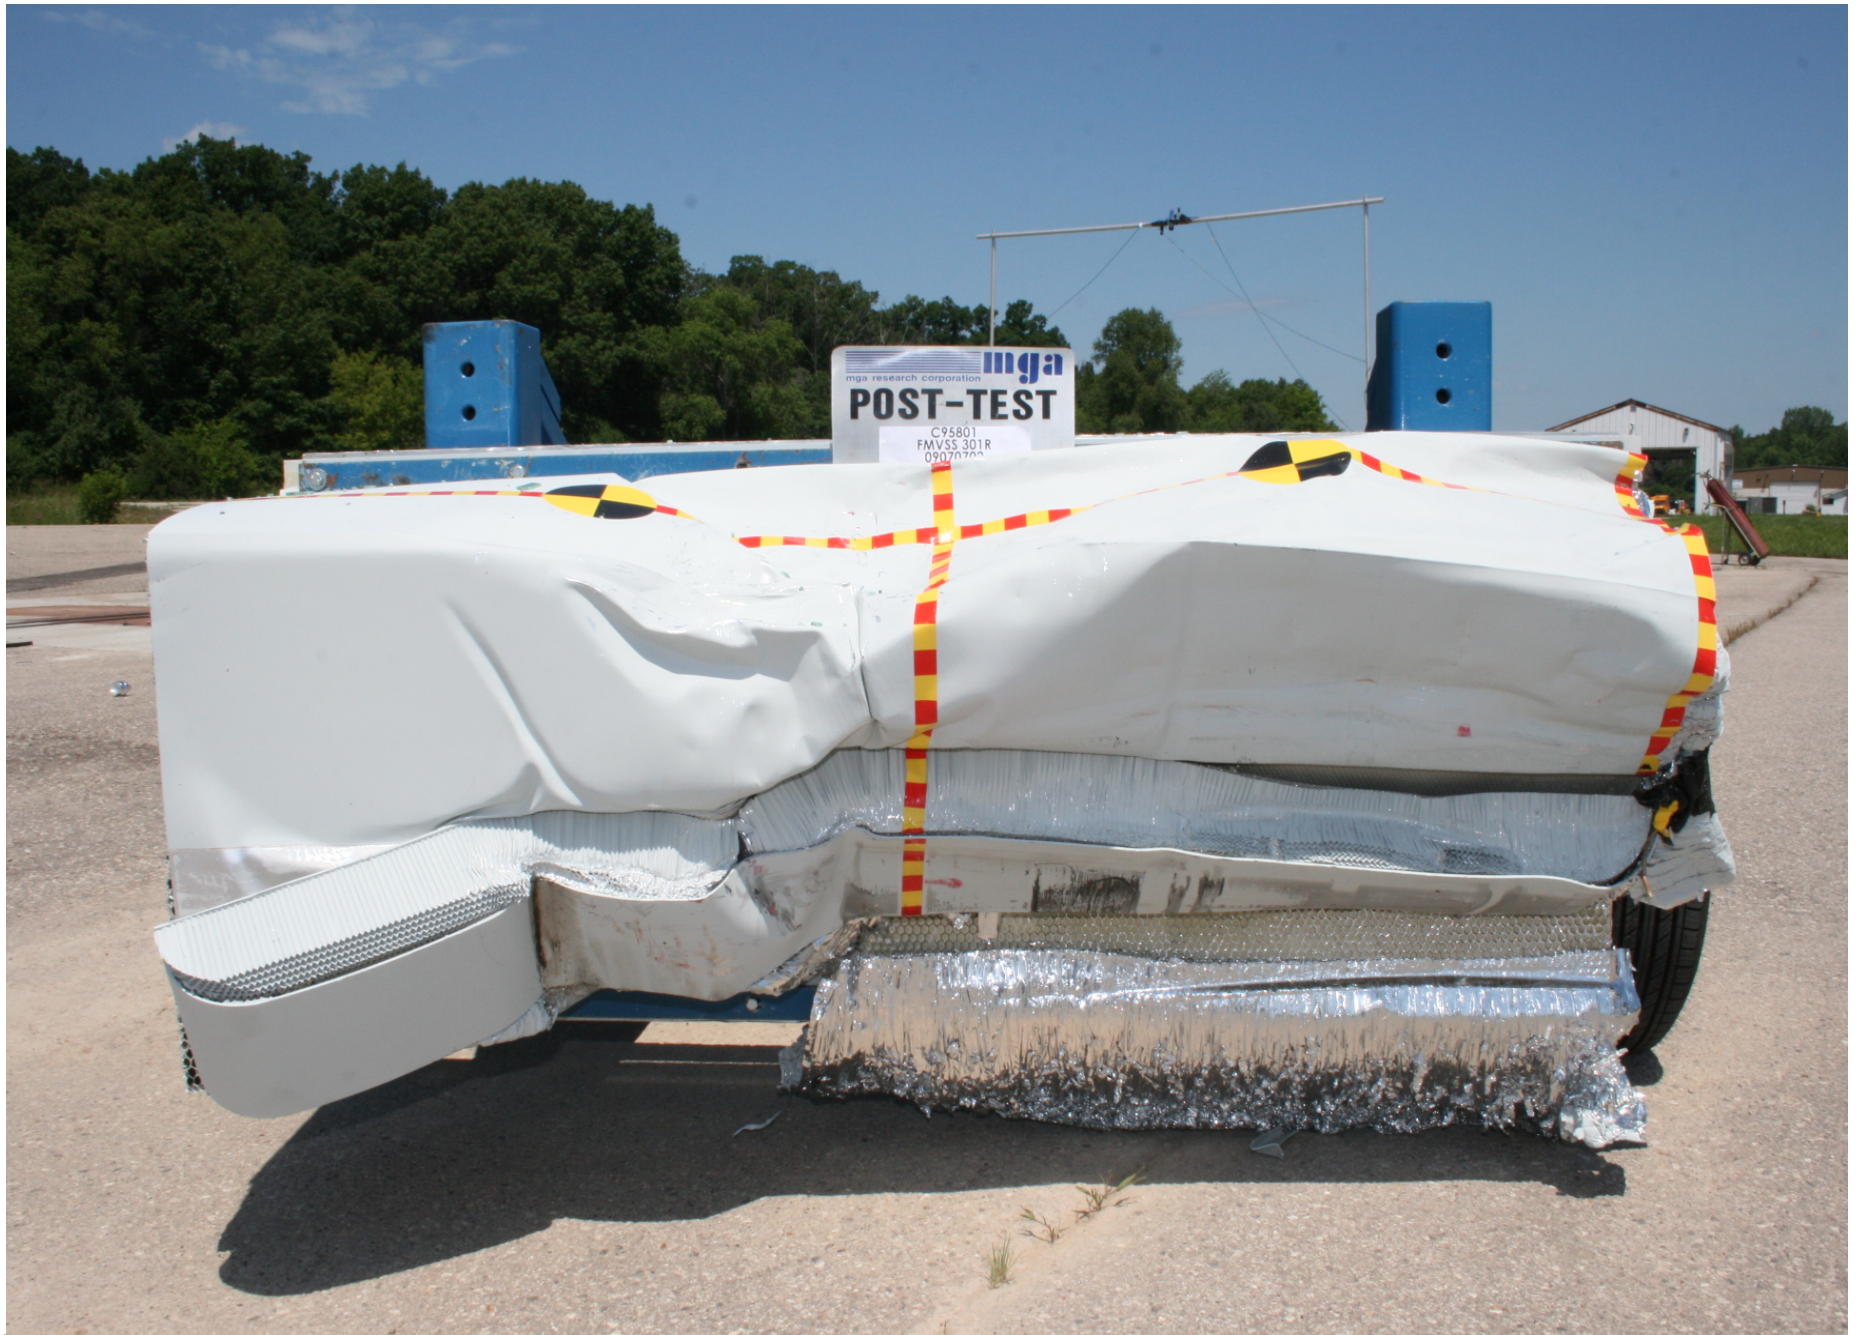
Post-Test Front View of MDB

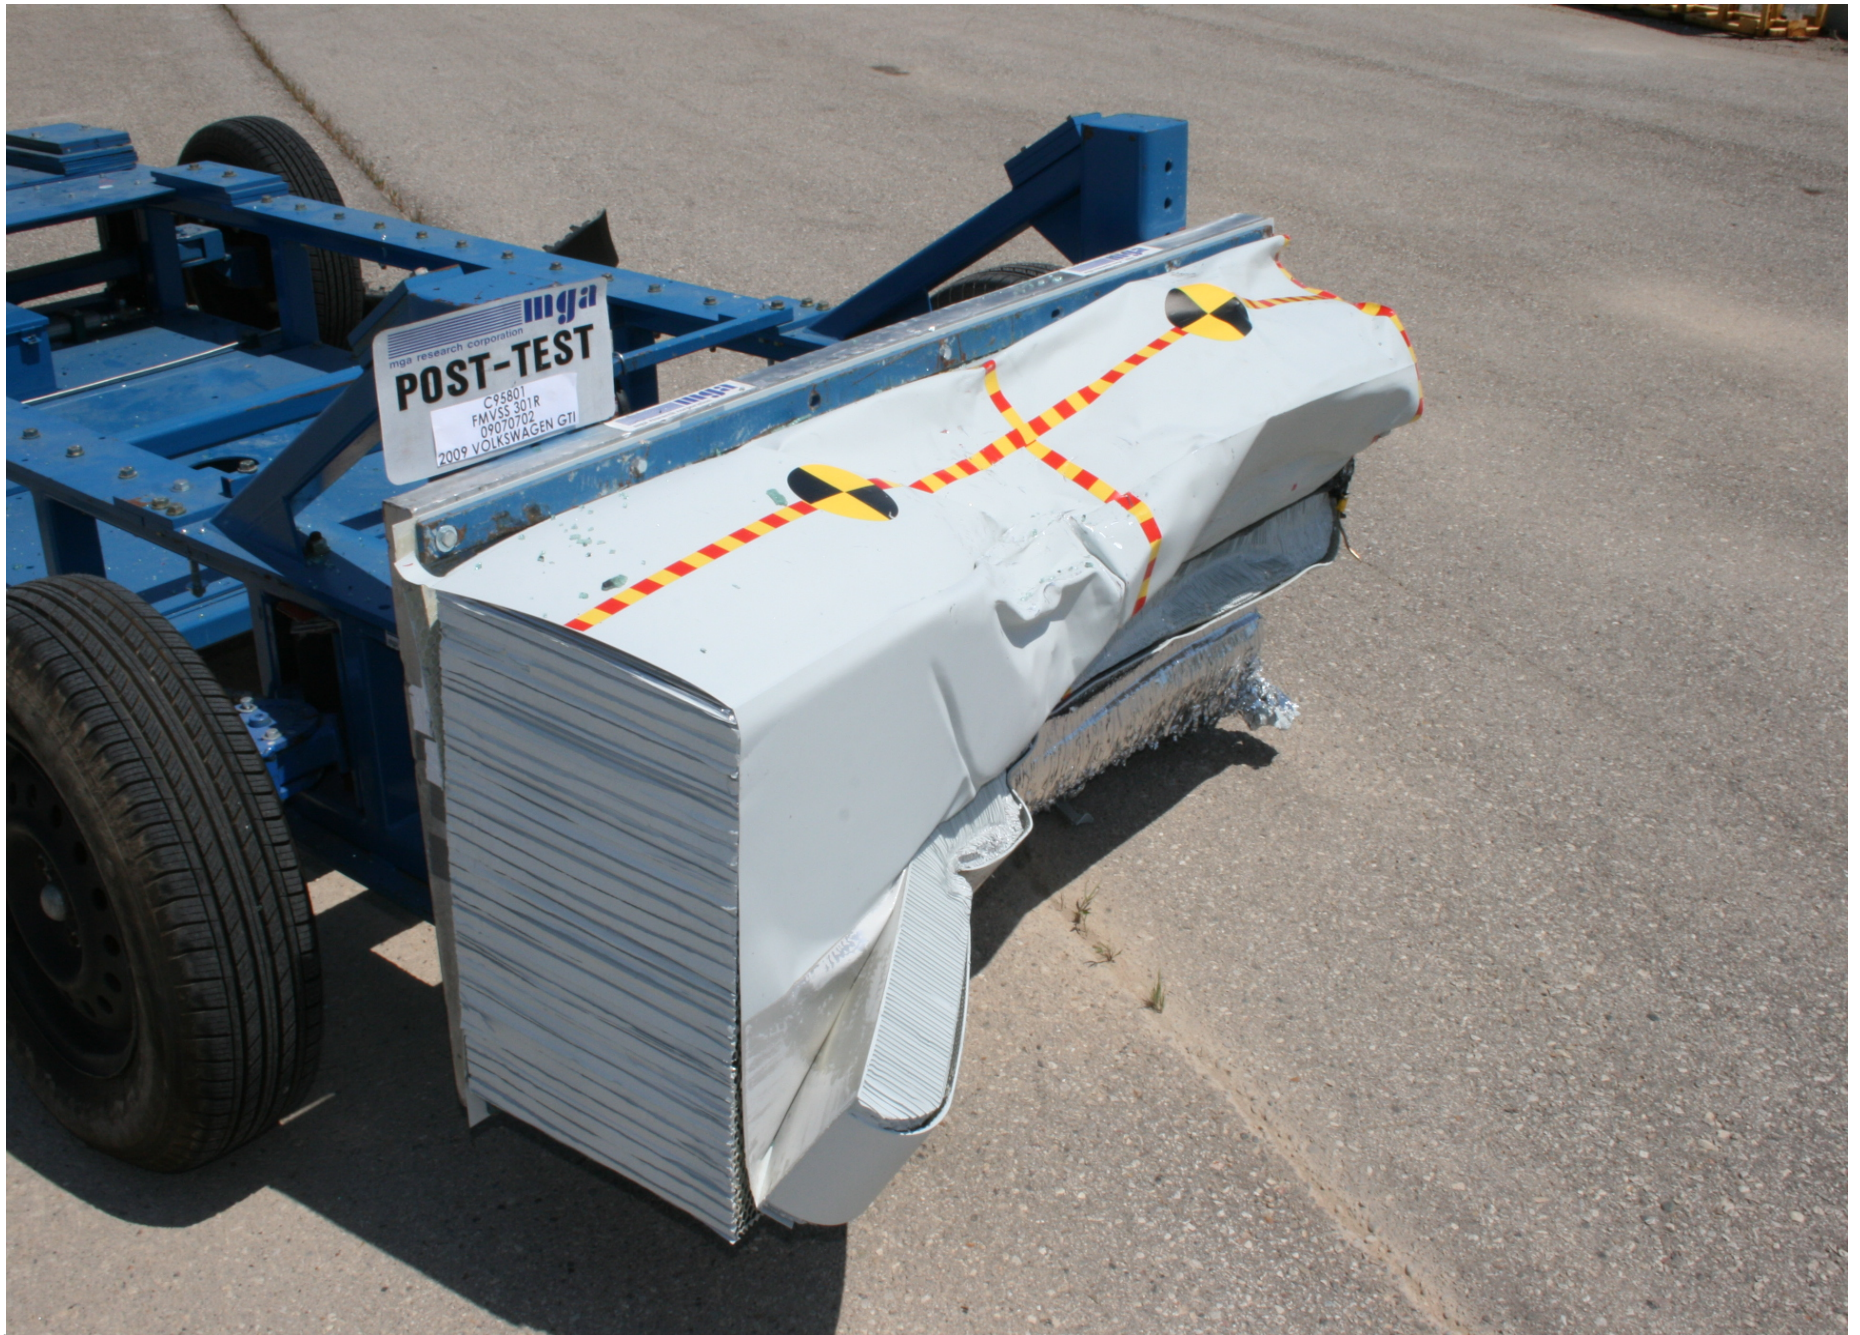
Post-Test ¾ Right Side View of MDB

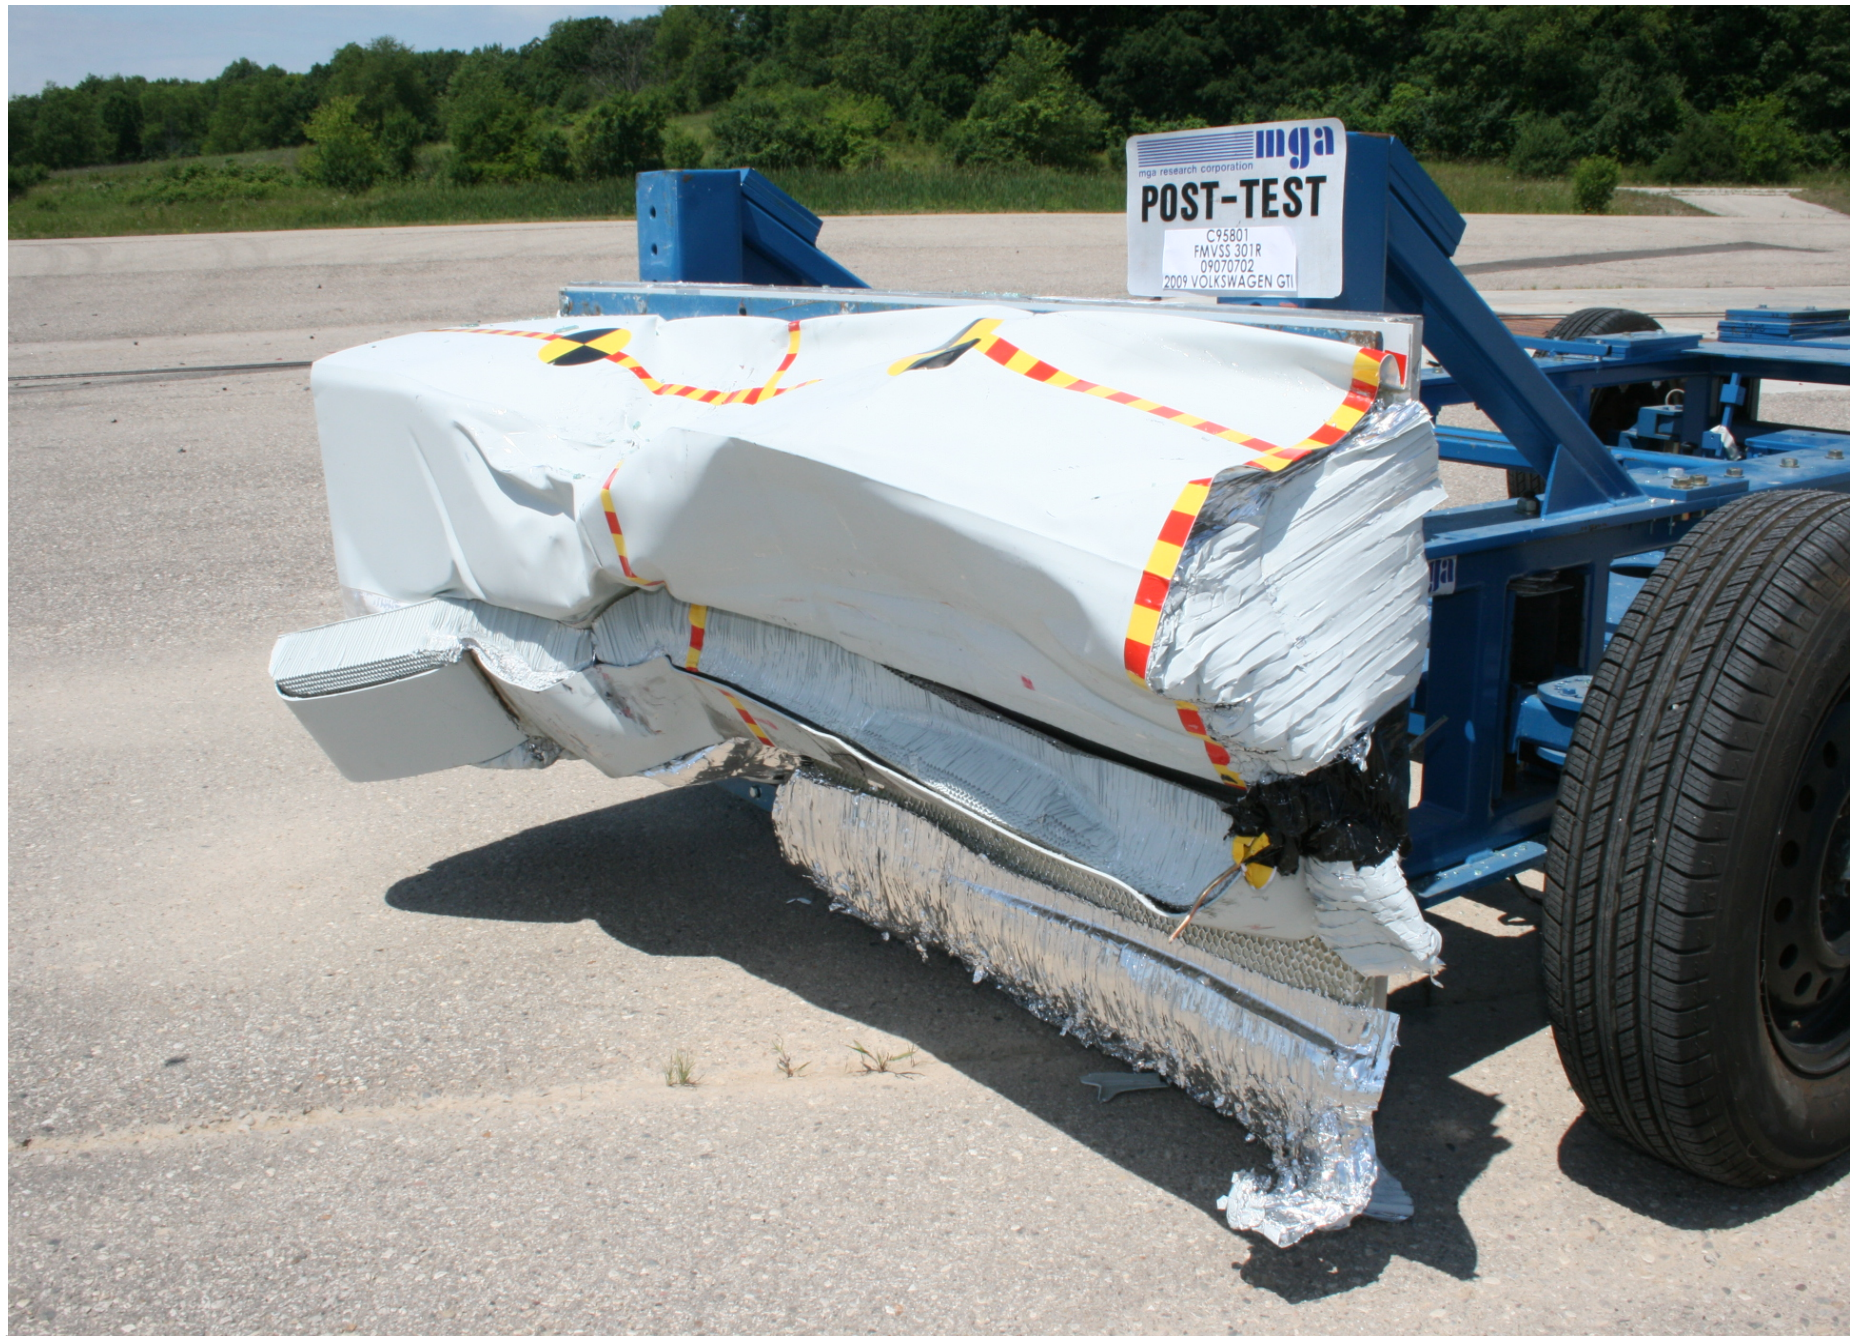
Post-Test ¾ Left Side View of MDB

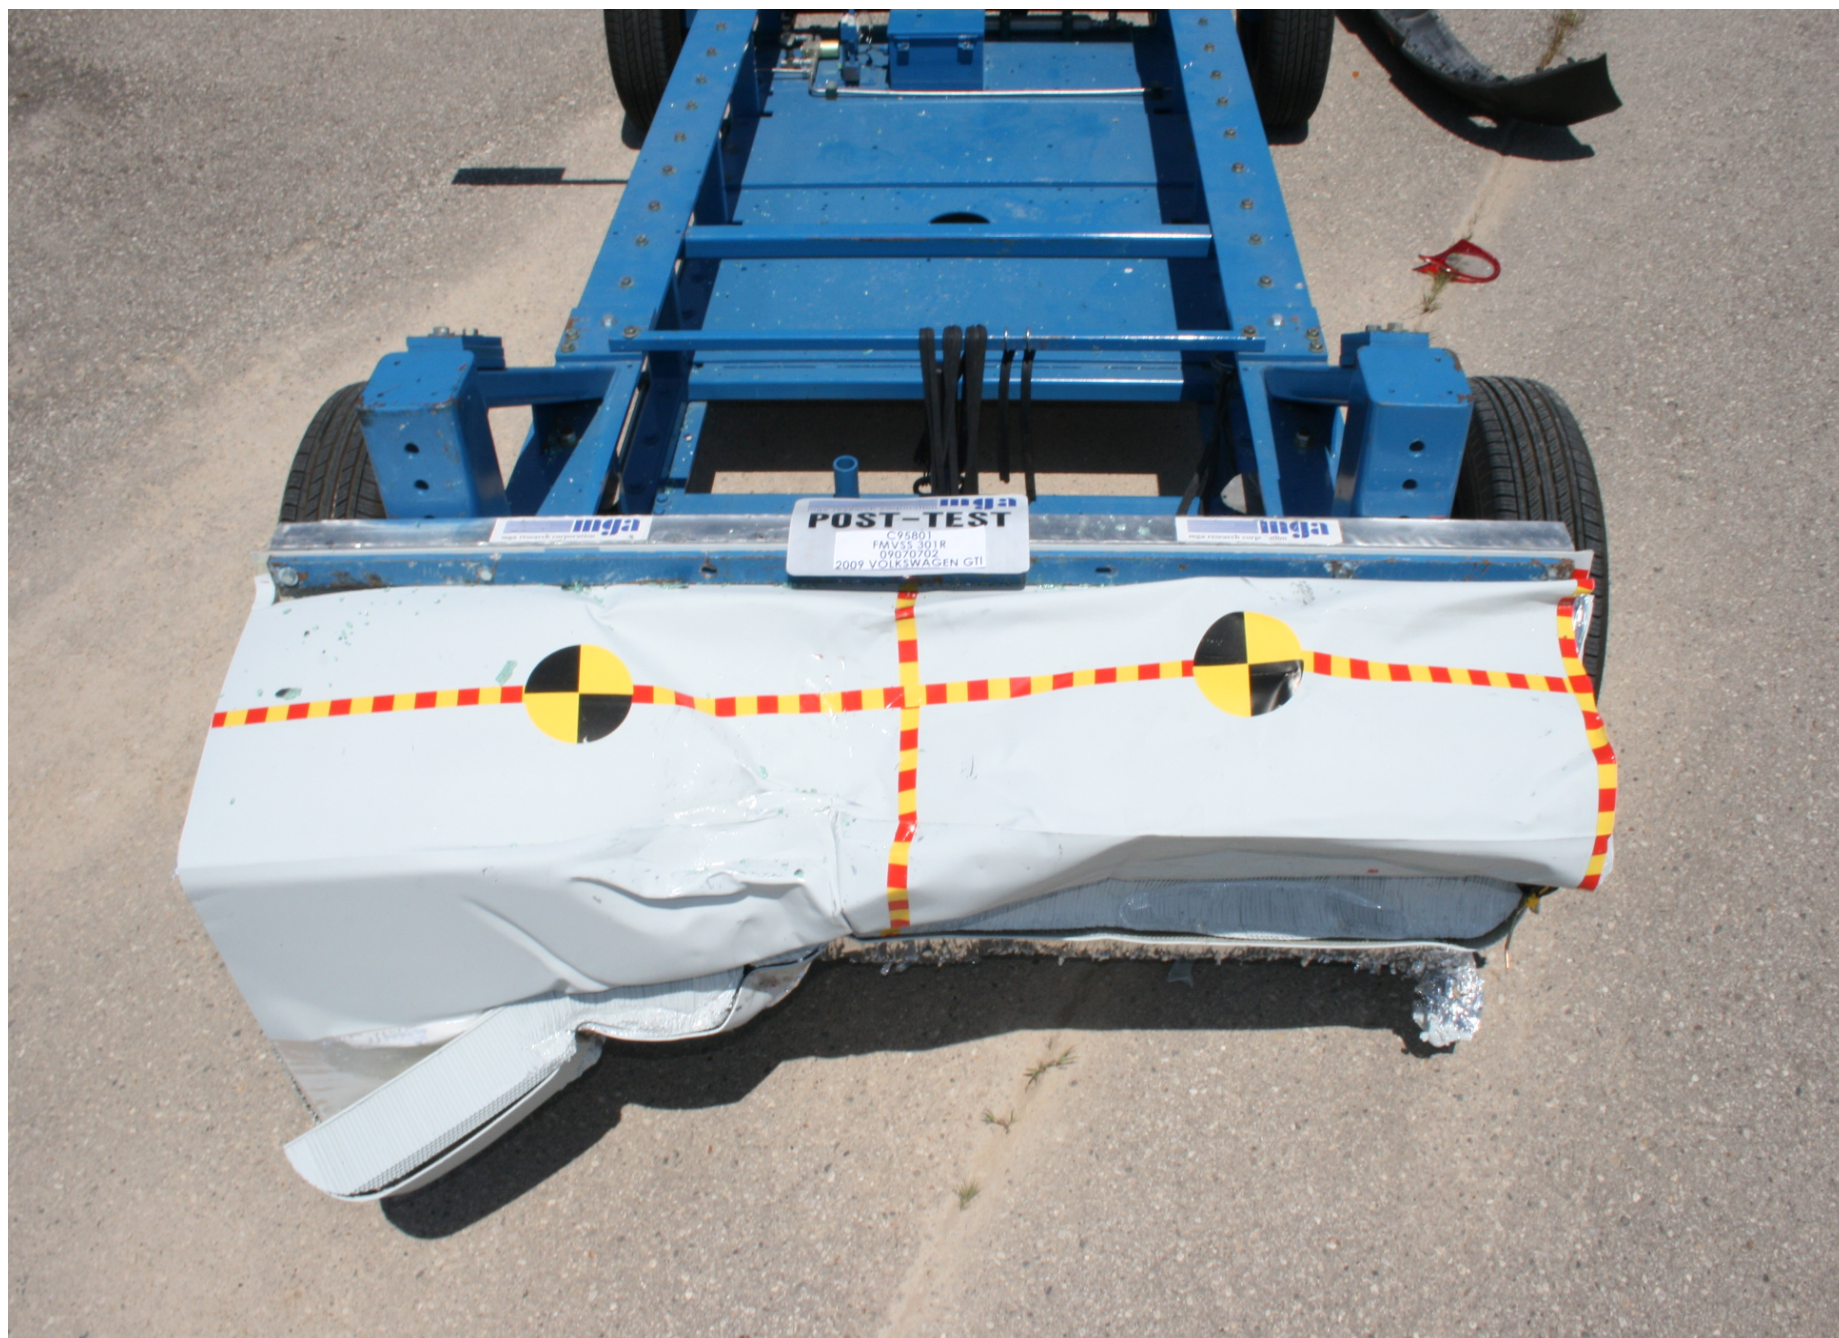
Post-Test Top View of MDB

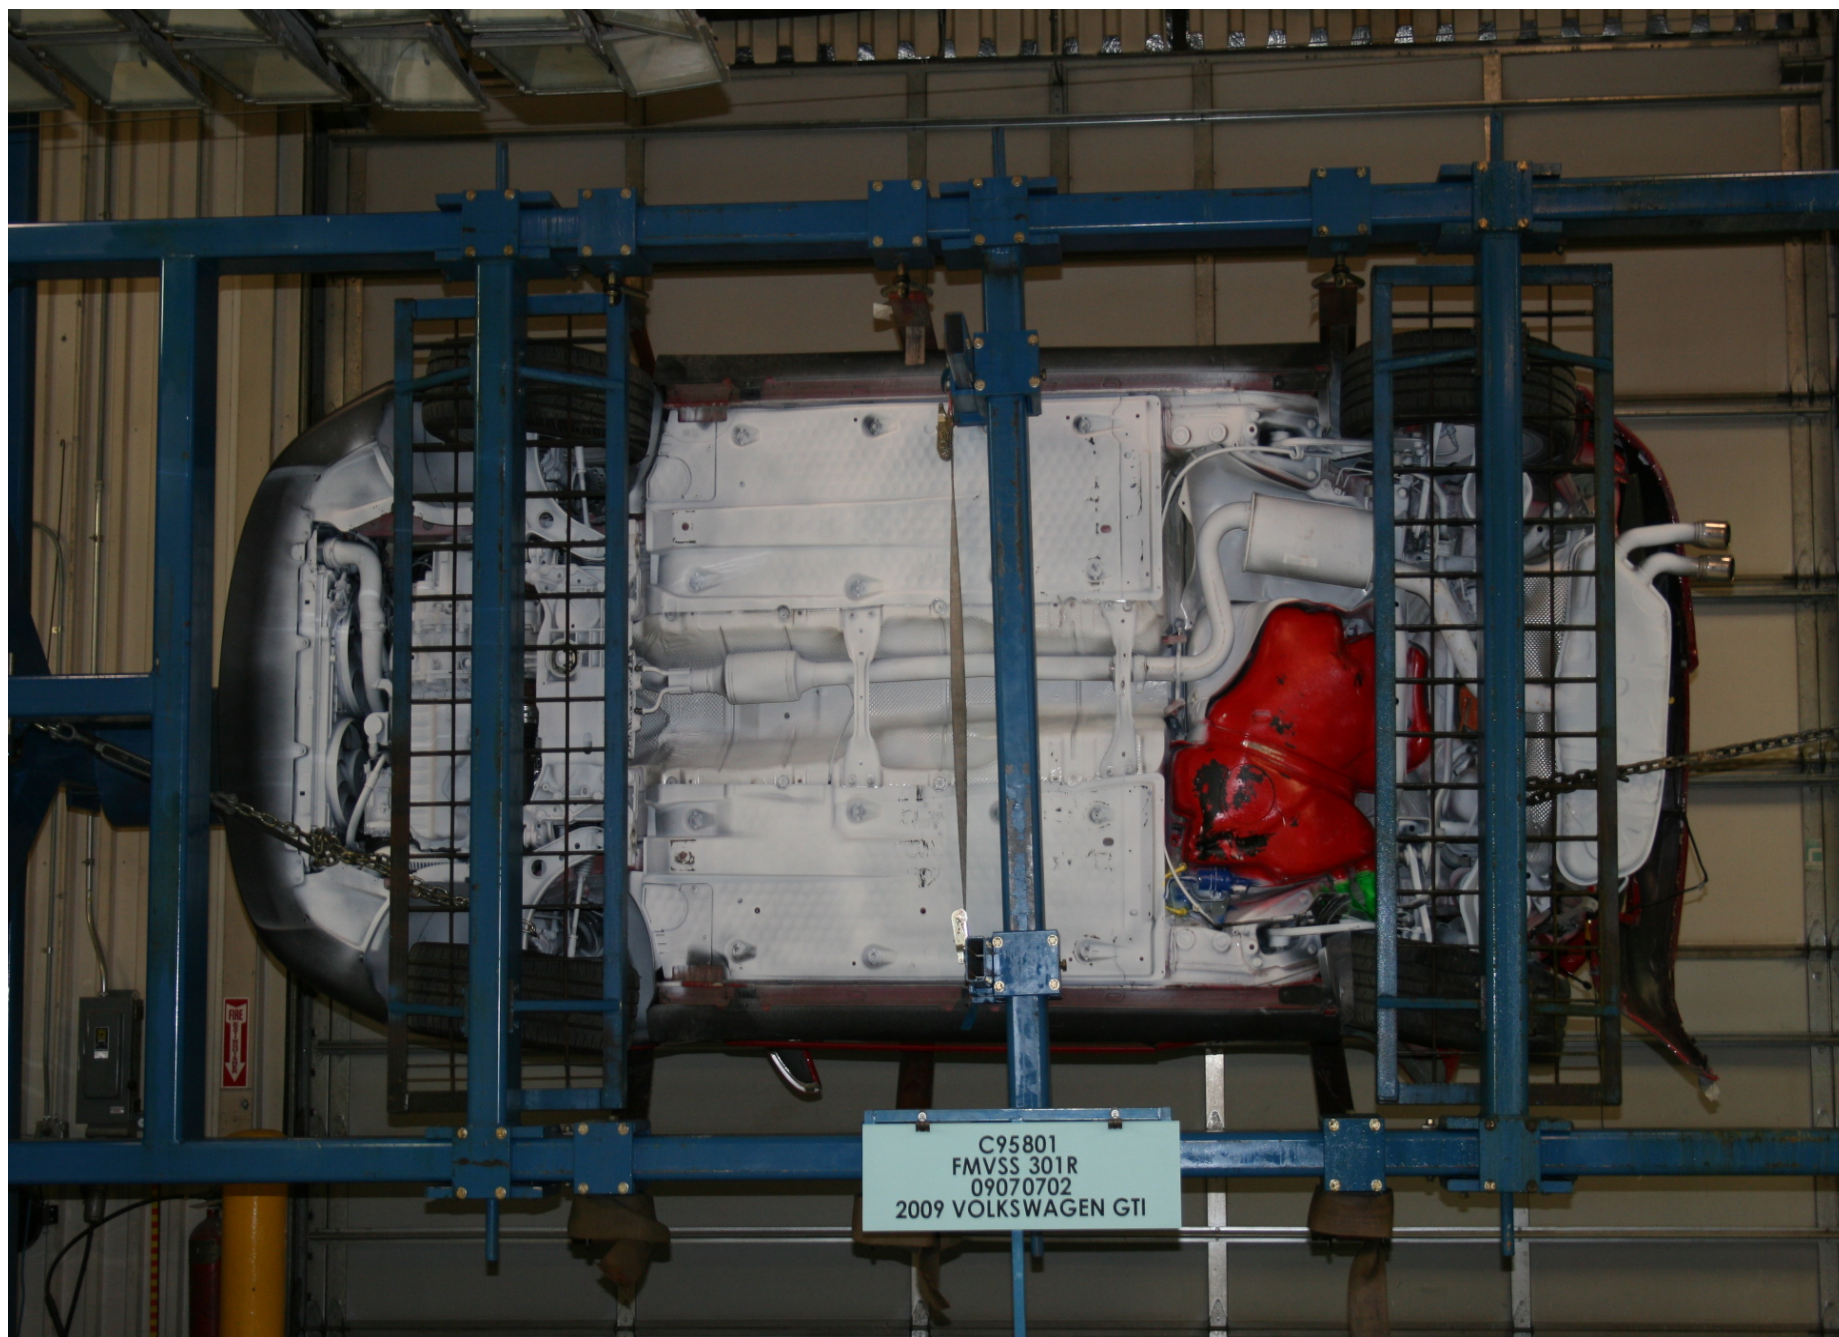
A-37.

- A. From impact until vehicle motion ceases: 0 g  
 (Maximum Allowable = 28 grams)
- B. For the 5 minute period after motion ceases: 0 g  
 (Maximum Allowable = 28 grams)
- C. For the following 25 minutes: 0 g  
 (Maximum Allowable = 28 grams/minute)
- D. Spillage: None

Static Rollover at 90 Degrees
